PROCEEDINGS OF THE INTERNATIONAL CONFERENCE ON ENVIRONMENTAL
MANAGEMENT, GEO-WATER AND ENGINEERING ASPECTS
WOLLONGONG / NEW SOUTH WALES / AUSTRALIA / 8-11 FEBRUARY 1993

Environmental impact of Roodbar landslide in Iran

S.A. Anvar, L. Behpoor & A. Ghahramani
Shiraz University, Iran

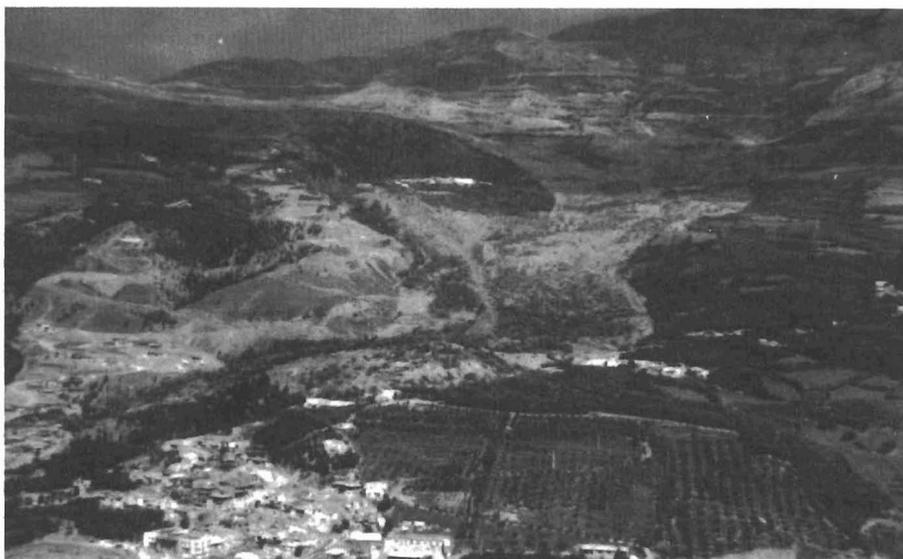
Fig. 1 Roodbar landslide

According to measurements and analysis carried out previously by Anvar, Behpoor and Ghahramani (1991) and recent investigations, the mechanism and characteristics of the slide can be summarized as follow. An overview of the slide area is shown in Fig.1 and the slide geometry based on new field survey of the Roodbar slide is presented in Fig. 2.

7. The slide destroyed several houses and irrigation ponds and about 50,000 olive trees and resulted in a considerable damage to the environment (see Fig. 1). It is to be noted that the petroleum line was repaired and rerouted within the first month, (see Fig. 3).

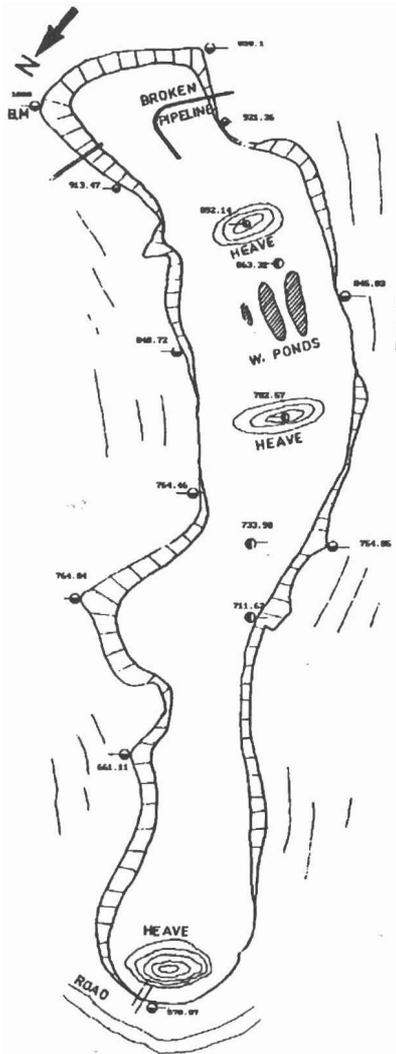
B. M. ELEVATION = 1000 m.
 ○ ELEVATION OF NATURAL GROUND
 ● ELEVATION AFTER SLIDING

Fig. 2 Slide geometry

1. The initial average slope of the ground of about 20 degrees has been reduced to about 15 degrees in upper part after the slide occurrence, the movement being up to 400 meters.

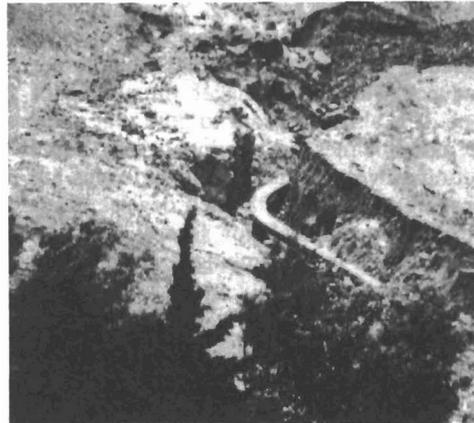
Fig. 3 Rerouted petroleum line

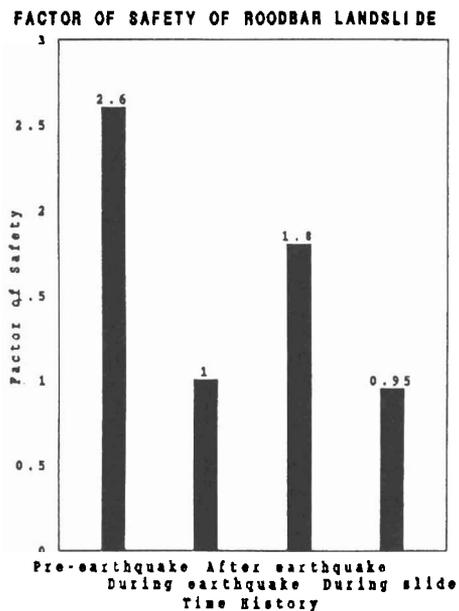
Fig. 4 Time sequence of factor of safety

2. By considering ground topography, measurements of soil properties, and using finite element and slope formulas it was shown that the slope had a factor of safety of about 2.6 prior to earthquake.

3. The acceleration of earthquake was reported to be 0.65 g at the station 65 km away from the area. Using this horizontal acceleration, calculations showed that the safety factor during the earthquake was reduced to 1. Although the slide did not occur during the earthquake, the earthquake acceleration could produce an initial slip.

4. After the earthquake, using the residual strength the slide had a factor of safety of about 1.8. Thus after initial slip which occurred during earthquake and its after shocks, the slope was still stable.

6. 48 hours after the earthquake, the reduction in soil residual shear strength due to petroleum and water penetrations resulted in dropping of factor of safety below unity. Consequently the slide was triggered and continued for almost a month before coming to rest, during which local heaves and water ponds were created.

Fig. 4 shows the variations of safety factor in time sequence.

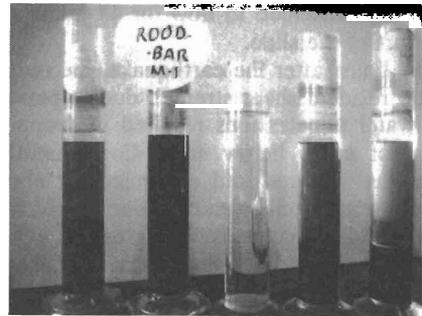
Fig. 5 Hydrometer showing oil content

Breakage of petroleum lines can cause landslides and severe damage to the environment. In the case of Roodbar, the petroleum line rupture resulted in the penetration of the oil in the fissures and subsequent reduction of the angle of internal friction and cohesion of the soil. In Roodbar before the earthquake soil parameters were $c = 140$ kpa and angle of internal friction $\phi = 27.5$ degrees. After the initial shock of the earthquake the strength parameters were reduced to residual, $c = 100$ kpa and $\phi = 20$ degrees. However the slope had still sufficient factor of safety to be stable after the earthquake. The infiltration of petroleum and water reduced the angle of internal friction and cohesion with subsequent triggering of the slide. The soil samples which were taken from the slide area were tested. The hydrometer test shows the existence of petroleum (see Fig. 5) To further study this phenomenon, the soil samples taken

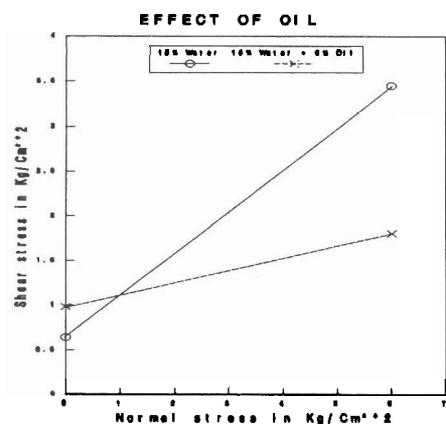
Fig. 6 Shear strength with oil

from the slope were mixed with different amount of oil and strength parameters were measured. Fig. 6 shows the results of this study. It is clear that a small amount of petroleum would considerably reduce the strength parameters. It should be noted that petroleum does not ordinarily penetrate deep into the soil due to high viscosity, however the existence of tension cracks due to either weathering or earthquake as in the

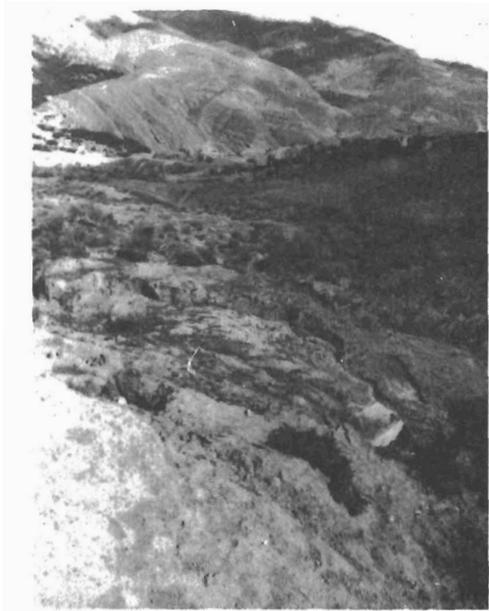
Fig. 7 Tension cracks on the slide

case of Roodbar (see Fig. 7) would ease the penetration of petroleum and subsequent reduction in soil strength, thus weak zones are produced which may trigger the sliding of the slope. It is also important to note that although the gas pipelines are equipped with automatic shut-off valves, the petroleum pipelines are not normally equipped with such devices, therefore petroleum could leak for several hours before being shut off from pumping stations.
